U.S. PUBLIC LAND SURVEY MONUMENT RECORD

The SOUTHEAST corner of Section 7, T. 31 N., R. 11 E., Langlade County, WI
 Corner was (check all that apply)

The SOUTHEAST
 Corner of Section 7
 T. 31 N., R. 11 E.
 Langlade County, WI

INDEX No. J - 5 4311107 0000

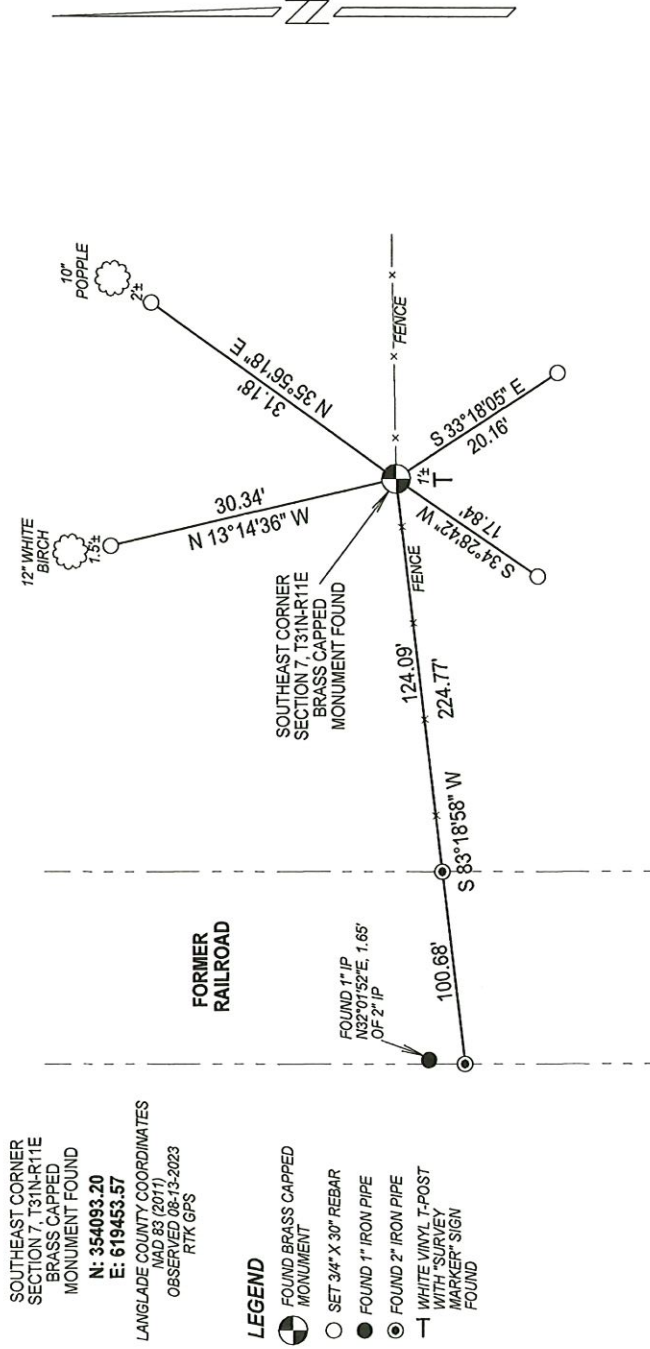
2023 - I found the brass capped iron pipe called for by Abendroth, along with the two remaining iron pipes referenced on his tie sheet.

Accepted brass capped iron pipe as corner location and tied out as shown below.

○ = Location of corner

NOTES
 - SKETCH NOT DRAWN TO SCALE.
 - TIE BEARINGS SHOWN ARE LANGLADE COUNTY GRID BEARINGS.
 - ALL TIES MEASURED ELECTRONICALLY WITH TOTAL STATION.

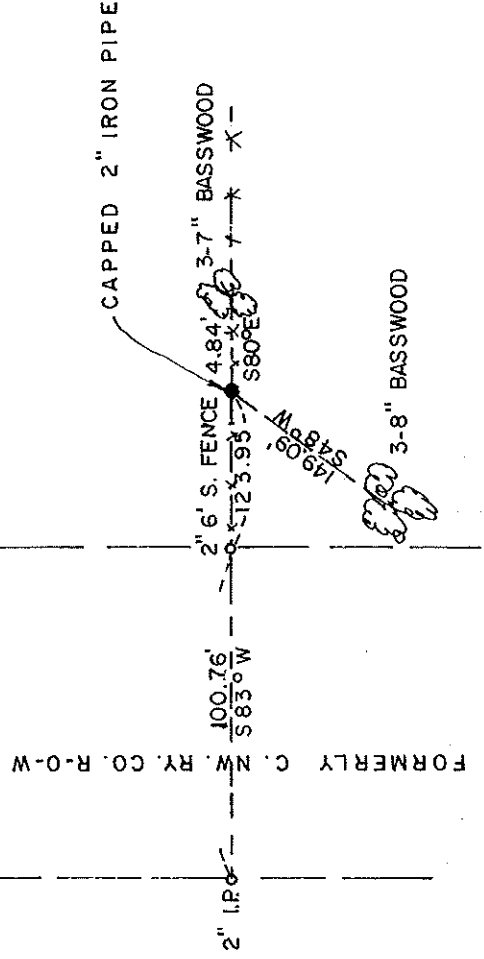
Found capped 2" iron pipe in place in fence line.
Corner fit railroad distance from centerline of right of way.

ALL BEARINGS MAGNETIC

No known material discrepancy.
