U.S. PUBLIC LAND SURVEY MONUMENT RECORD

The CENTER 1/4 corner of Section 12, T. 31 N., R. 11 E., Langlade County, WI
 Corner was (check all that apply)

The CENTER 1/4
 Corner of Section 12
 T. 31 N., R. 11 E.
 Langlade County, WI

CERTIFIED LAND CORNER RESTORATION

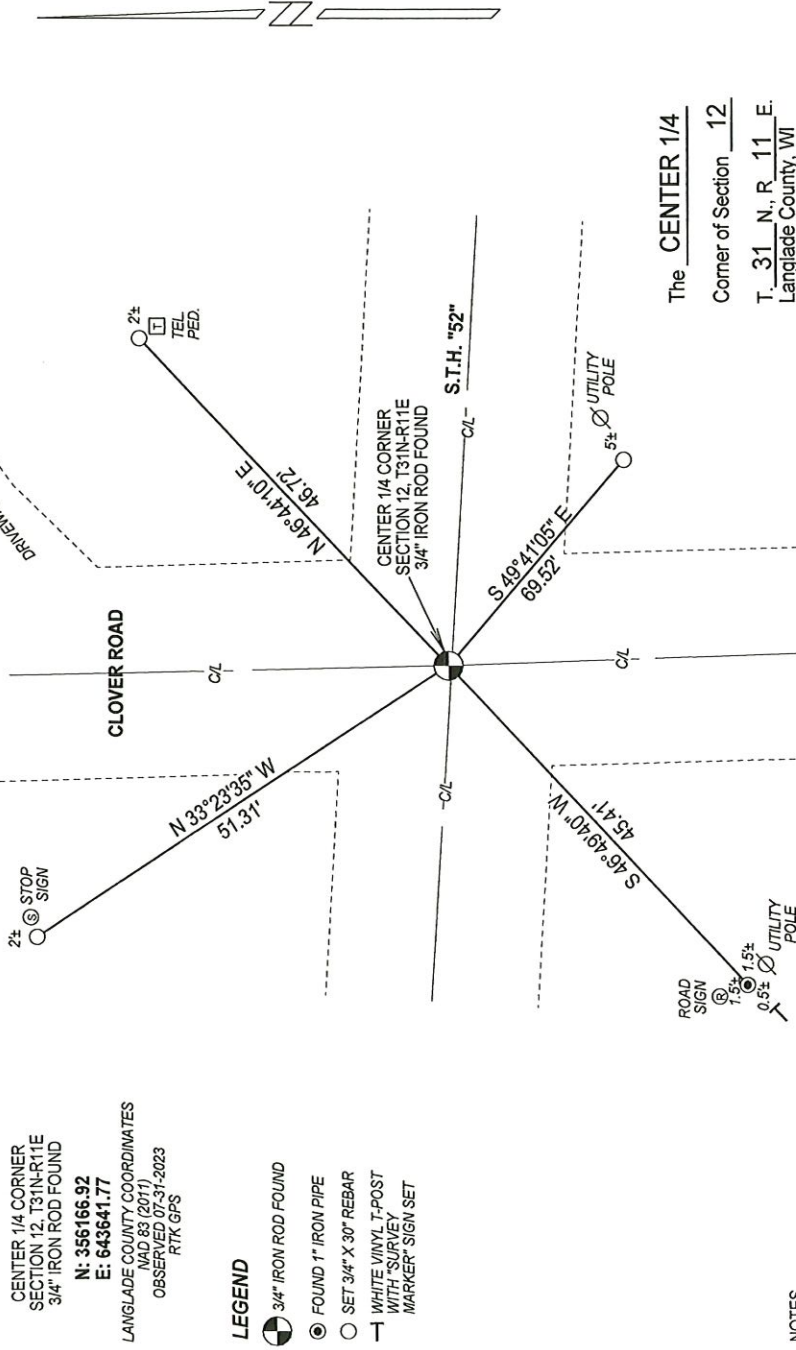
Accepted 3/4" iron rod as corner location and tied out as shown below.

Describe the accessories used to perpetuate the location of the corner. Include a plan view drawing and indicate accessories found/set. Describe measuring point on bearing trees. Show any topographic features that would aid in future recovery of the corner.

NOTES
 - SKETCH NOT DRAWN TO SCALE.
 - TIE BEARINGS SHOWN ARE LANGLADE COUNTY GRID BEARINGS.
 - ALL TIES MEASURED ELECTRONICALLY WITH TOTAL STATION.

2023 - I found a 3/4" iron rod 6" below the road surface at the corner location as set by Stibbe. Verified location from previous survey work in the area and set additional witness monuments.

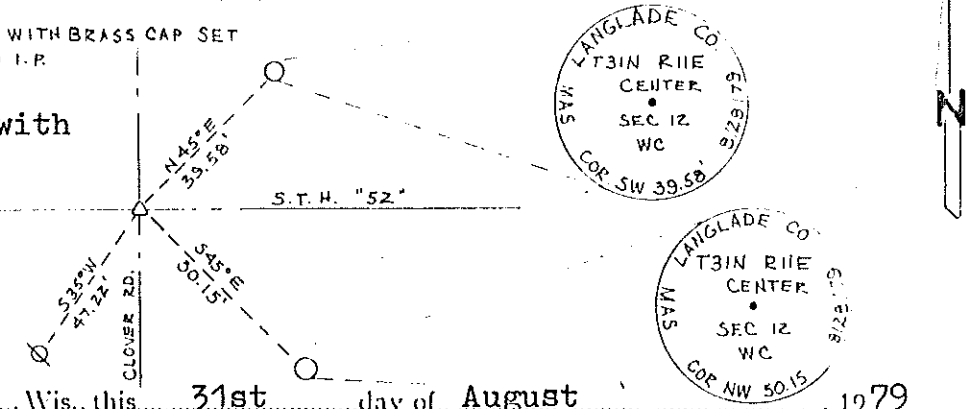
○ - 1 7/8" (OUTSIDE DIAMETER) B.I.P. WITH BRASS CAP SET
△ - 3/4" x 24" I.R. SET OVER FOUND I.P.

Note: Bearings taken with recon compass.

P.K. IN POWER POLE
P.P. NO. 3111-12L26

Found 2 1/4" (outside diameter) iron pipe 28" below top of pavement. Top of found iron pipe was bent to southwest.

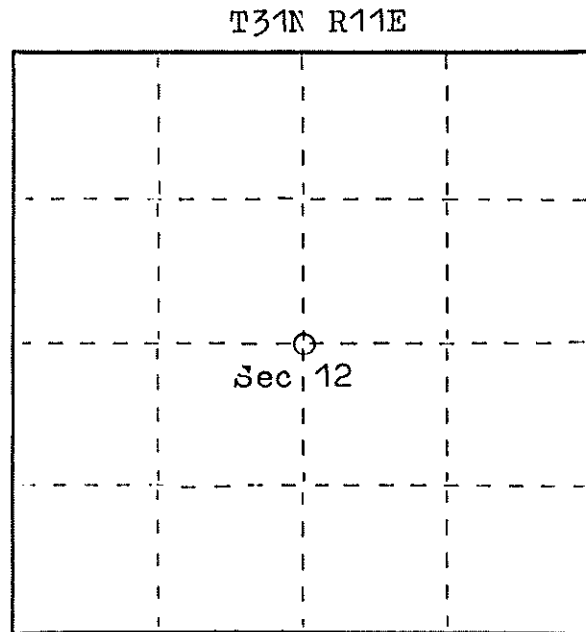
○ = Corner monument restored.
