U.S. PUBLIC LAND SURVEY MONUMENT RECORD

The SOUTH 1/4 corner of Section 26, T. 31 N., R. 11 E., Langlade County, WI
Corner was (check all that apply)

The SOUTH 1/4
Corner of Section 26
T. 31 N., R. 11 E.
Langlade County, WI

CERTIFIED LAND CORNER RESTORATION

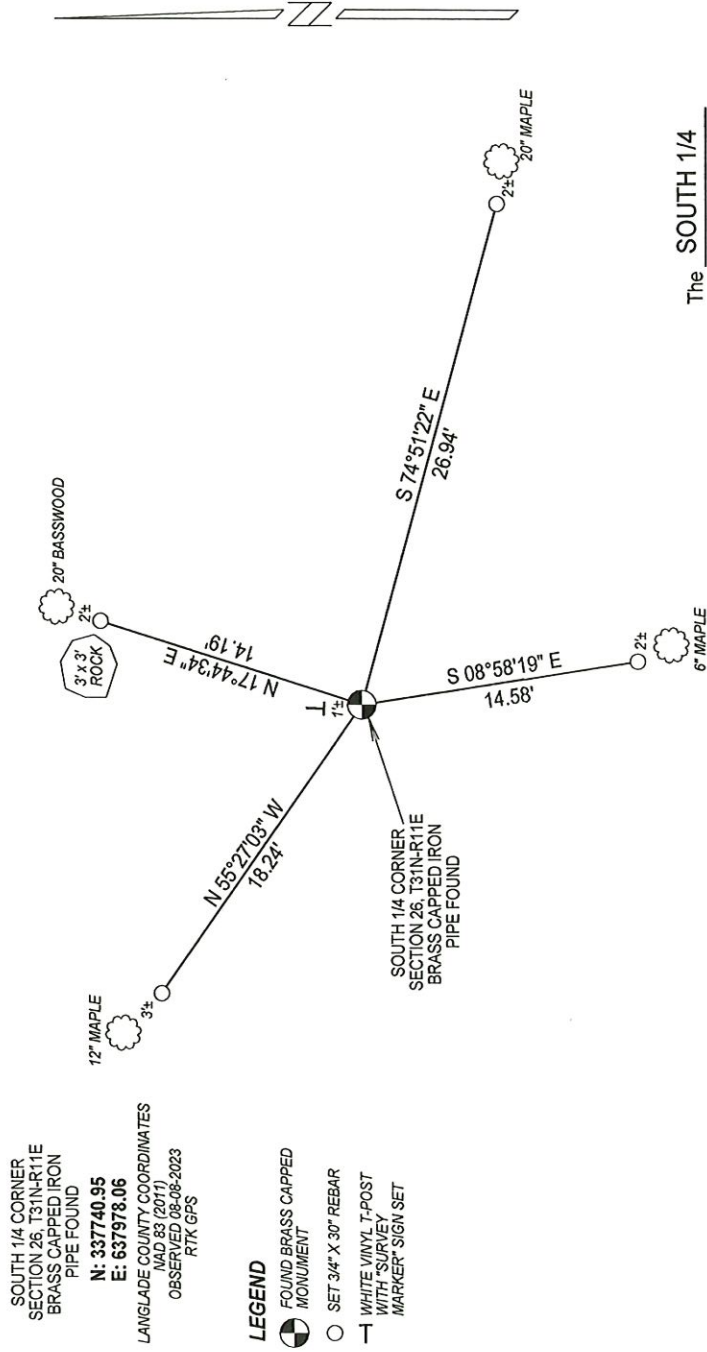
Accepted brass capped iron pipe as corner location and tied out as shown below.

NOTES
- SKETCH NOT DRAWN TO SCALE
- TIE BEARINGS SHOWN ARE ASSUMED
- ALL TIES MEASURED ELECTRONICALLY WITH TOTAL STATION.

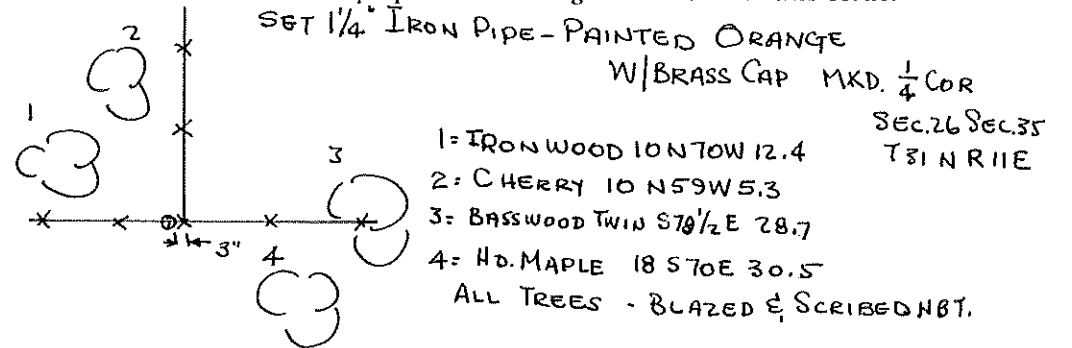
Description of monument and accessories I established to perpetuate the original location of this corner.

○ = Corner monument restored.
