U. S. PUBLIC LAND SURVEY MONUMENT RECORD

The South Quarter corner of Section 29, Township 31 North, Range 11 East, Langlade County, Wisconsin.

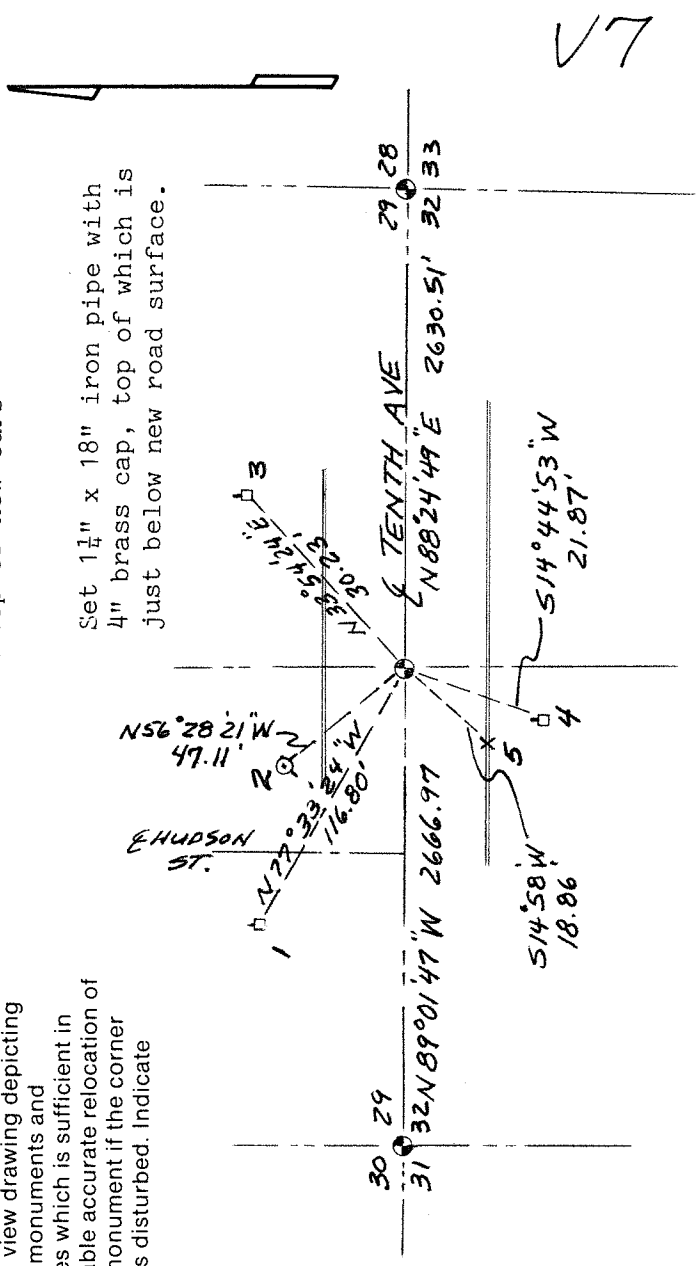
1. PK nail found in NE side of power pole
 2. Center of top of new hydrant (installed 1993)
 3. PK nail & washer set in NW side of power pole
 4. " " " " " " " "

5. Chiseled "X" in top of new curb
- (d) Show a plan view drawing depicting the relevant monuments and reference ties which is sufficient in detail to enable accurate relocation of the corner monument if the corner monument is disturbed. Indicate north.

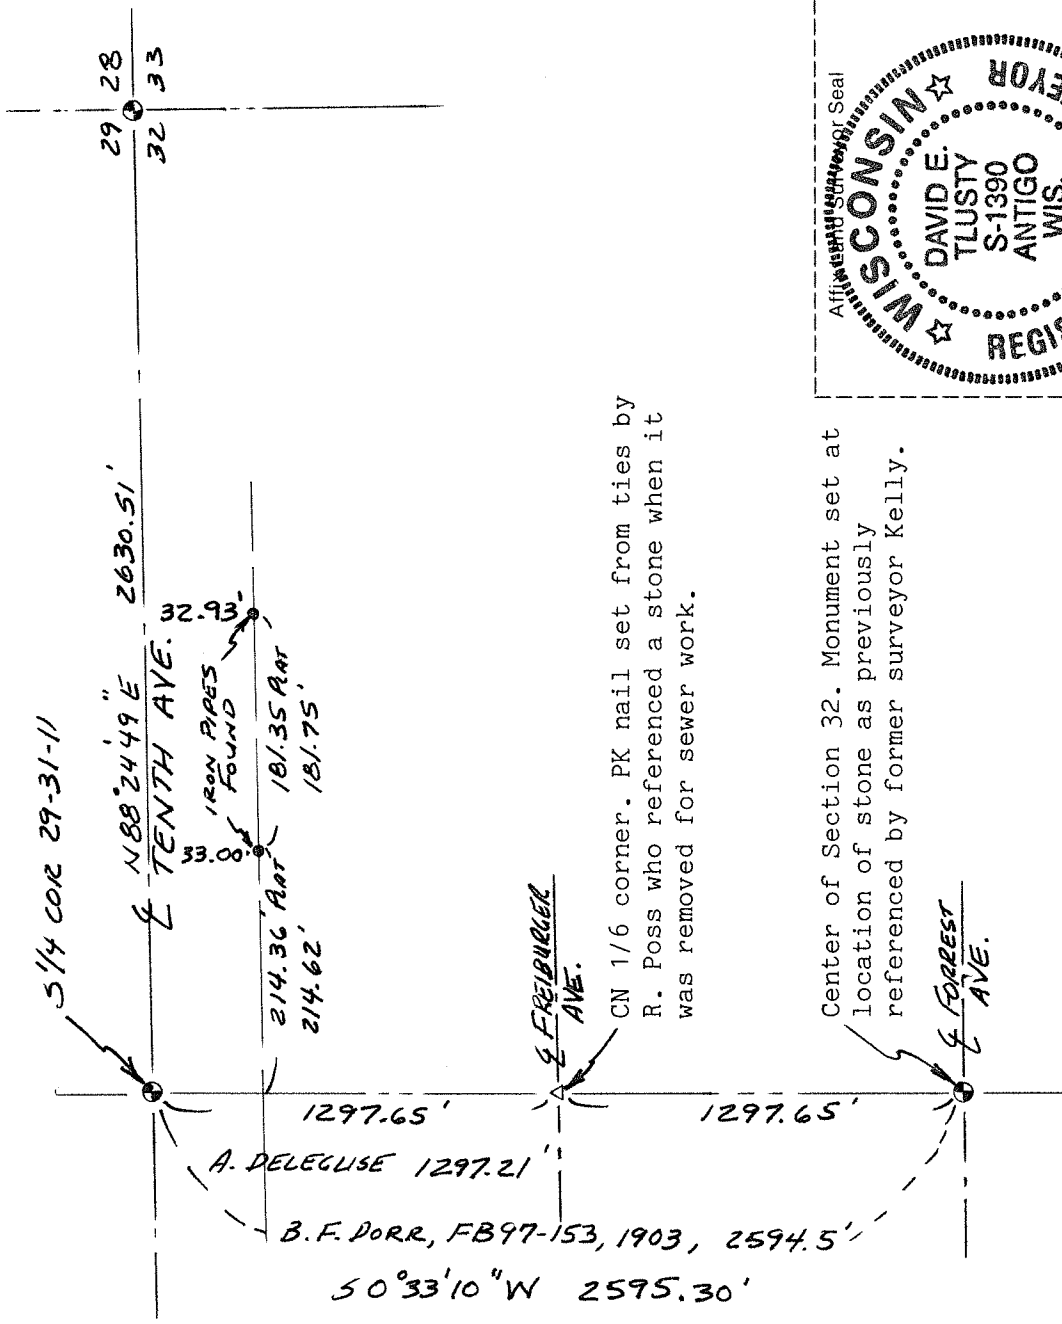
- (b) Describe any record evidence, monument evidence, occupational evidence, testimonial evidence or any other material evidence you considered, and whether the monument was found or placed.
The original corner was established in 1860 by Hiram C. Fellows. Original bearing trees: sugar, 12", S55°E, 27 lks., and birch, 20", N04°W, 19 lks. F.A. Deeglise, in 1878 for original plat of Antigo, found original BT's, set new post and marked new BT's. B.F. Dorr, in 1919 (FB97-153) measured from this corner 2594.5' south to the center of Section 32. Alex Deeglise, in 1919, on the plat of Berners Second Addition shows this corner as being a stone and the distance to a stone at the CN1/16 corner of Section 32 was measured as 1297.21'. April 1994, I find that all original and subsequent evidence of the corner has been destroyed by construction of sewer lines in 10th Ave. I re-set this corner on an extension of a line from the C $\frac{1}{4}$ of Section 32, through the CN 1/16 of Section 32, and at the same distance between said corners. See comparative sketch on reverse.
