U.S. PUBLIC LAND SURVEY MONUMENT RECORD

The SOUTHEAST corner of Section 24, T. 31 N., R. 12 E., Langlade County, WI
Corner was (check all that apply)

The SOUTHEAST
Corner of Section 24
T. 31 N., R. 12 E.
Langlade County, WI

CERTIFIED LAND CORNER RESTORATION

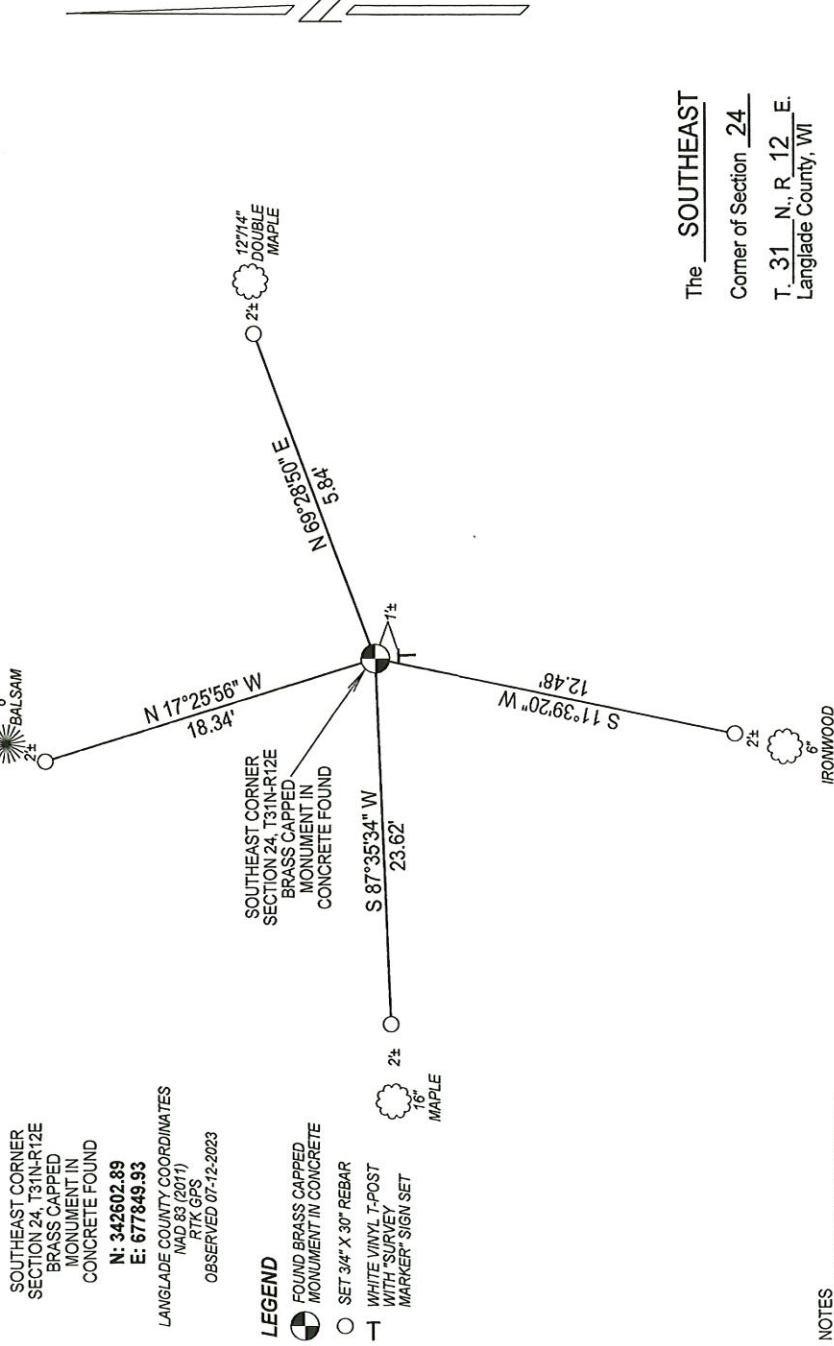
Accepted brass capped monument as corner location and tied out as shown below.

Describe the accessories used to perpetuate the location of the corner. Include a plan view drawing and indicate accessories found/set. Describe measuring point on bearing trees. Show any topographic features that would aid in future recovery of the corner.

NOTES
- SKETCH NOT DRAWN TO SCALE.
- TIE BEARINGS SHOWN ARE LANGLADE COUNTY GRID BEARINGS.
- ALL TIES MEASURED ELECTRONICALLY WITH TOTAL STATION.

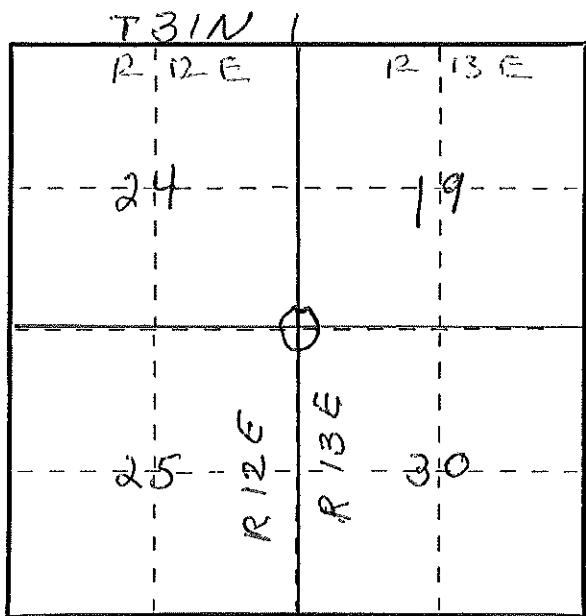
4" BRASS CAP IN 2" IRON PIPE
IN cement
MARKED →
Fence south

New BT's
Red maple 7" N 76 E 9' 3"
" " 10" S 84 W 26' 1"
Balsam 7" N 4° W 10' 1"
Red maple 7" N 70 W 20' 8"

○ = Corner monument restored.
