# U.S. PUBLIC LAND SURVEY MONUMENT RECORD

The Southwest corner of Section 24, T.31N., R.13E., Langlade County, WI  
Corner was (check all that apply)

INDEX No. **R - 21** (31-13)

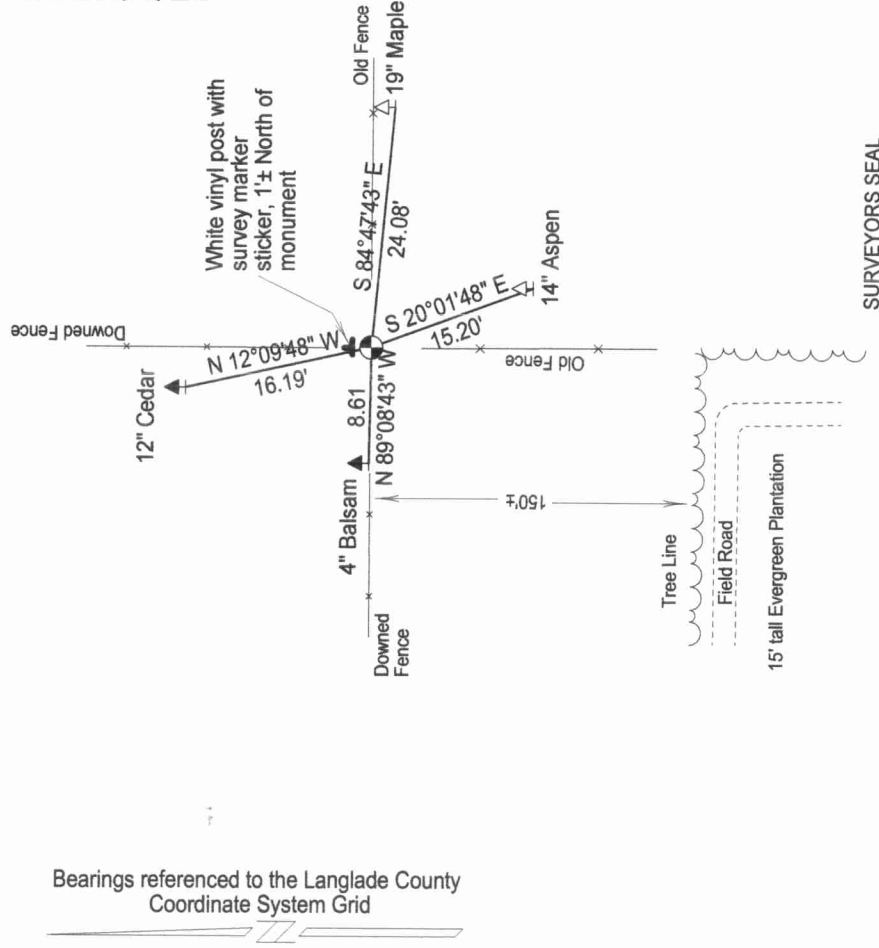
In 2007, I set a 2.375" X 30" iron pipe with a brass cap as the corner, a white vinyl post 1± North, and four new bearing trees as shown below.

Bearings referenced to the Langlade County Coordinate System Grid

Not drawn to any scale.  
Bearings and distances measured to nail in the side of bearing trees, utilizing a total station.  
All bearing trees have Langlade County plaque and aluminum nail on side of tree near base.
