U. S. PUBLIC LAND SURVEY MONUMENT RECORD

Section corner to Sections 19, 20, 29, and 30, T.31N., R.15E.

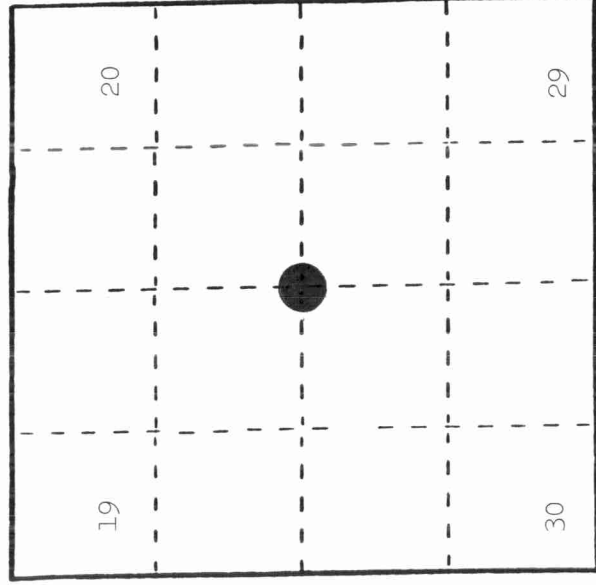
- (a) Identify the corner by reference to the U.S. public land survey system.
O = Corner monument restored.

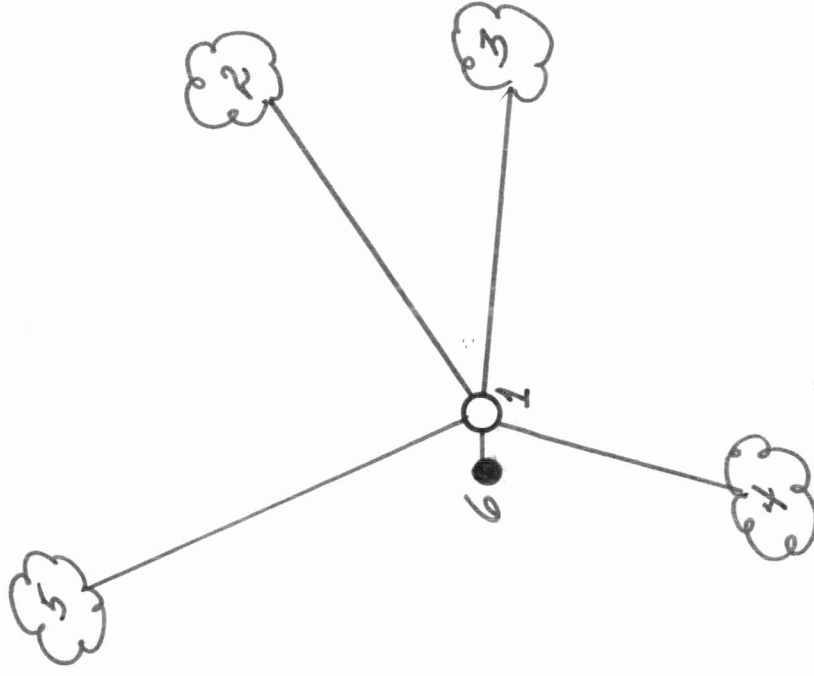
- (d) Show a plan view drawing depicting the relevant monuments and reference ties which is sufficient in detail to enable accurate relocation of the corner monument if the corner monument is disturbed. Indicate north.

1. 2" x 30" aluminum monument stamped to identify the corner; in a mound of stone.
2. Red Oak, 12", N.64°E., 23.83 feet
3. Hemlock, 6", S.83°E., 18.69 feet
4. Red Oak, 11", S.11°W., 16.58 feet
5. Red Oak, 10", N.28°W., 23.94 feet
6. Steel Sign Post, West, 1.0 foot
