U. S. PUBLIC LAND SURVEY MONUMENT RECORD

Quarter corner to Sections 17 and 20, T.31N., R.15E.

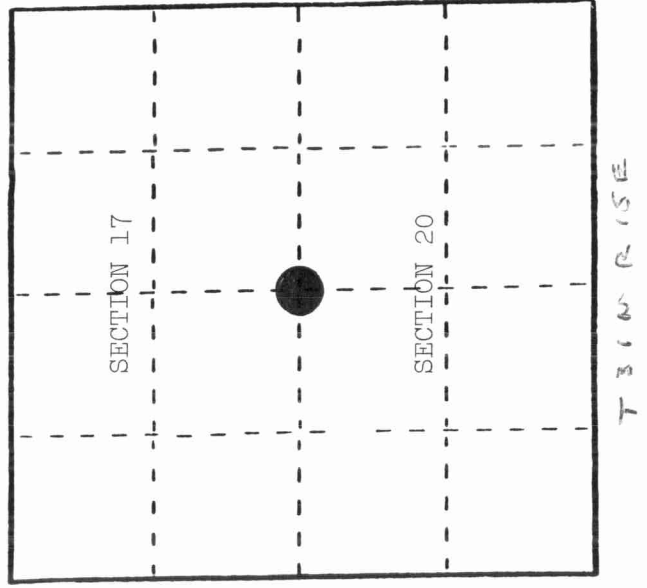
- (d) Show a plan view drawing depicting the relevant monuments and reference ties which is sufficient in detail to enable accurate relocation of the corner monument if the corner monument is disturbed. Indicate north.

1. 2" x 60" aluminum monument stamped to identify the corner.
2. Red Maple, 10", North, 6.08 feet
3. Cedar, 9", S.46°E., 25.83 feet
4. Cedar, 9", S.50°W., 9.25 feet
5. Steel Sign Post, East, 1.4 feet
