U. S. PUBLIC LAND SURVEY MONUMENT RECORD

The Southwest corner of Section 26, Township 32 North, Range 11 East, Langlade County, Wisconsin.

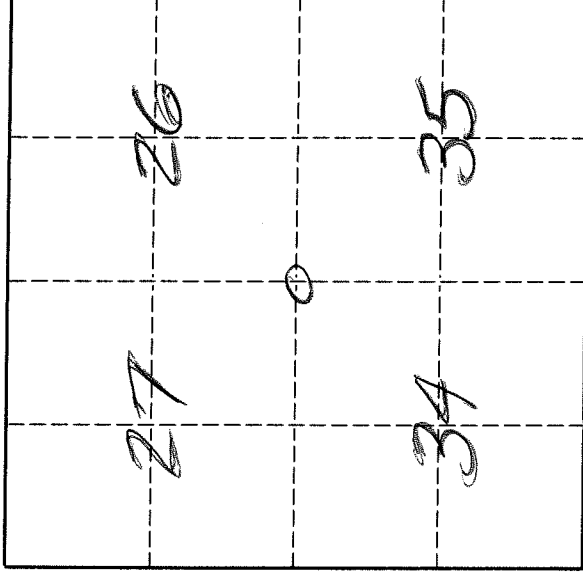
T. 32 N., R. 11 E.

- (a) Identify the corner by reference to the U.S. public land survey system.
 O = Corner monument restored.

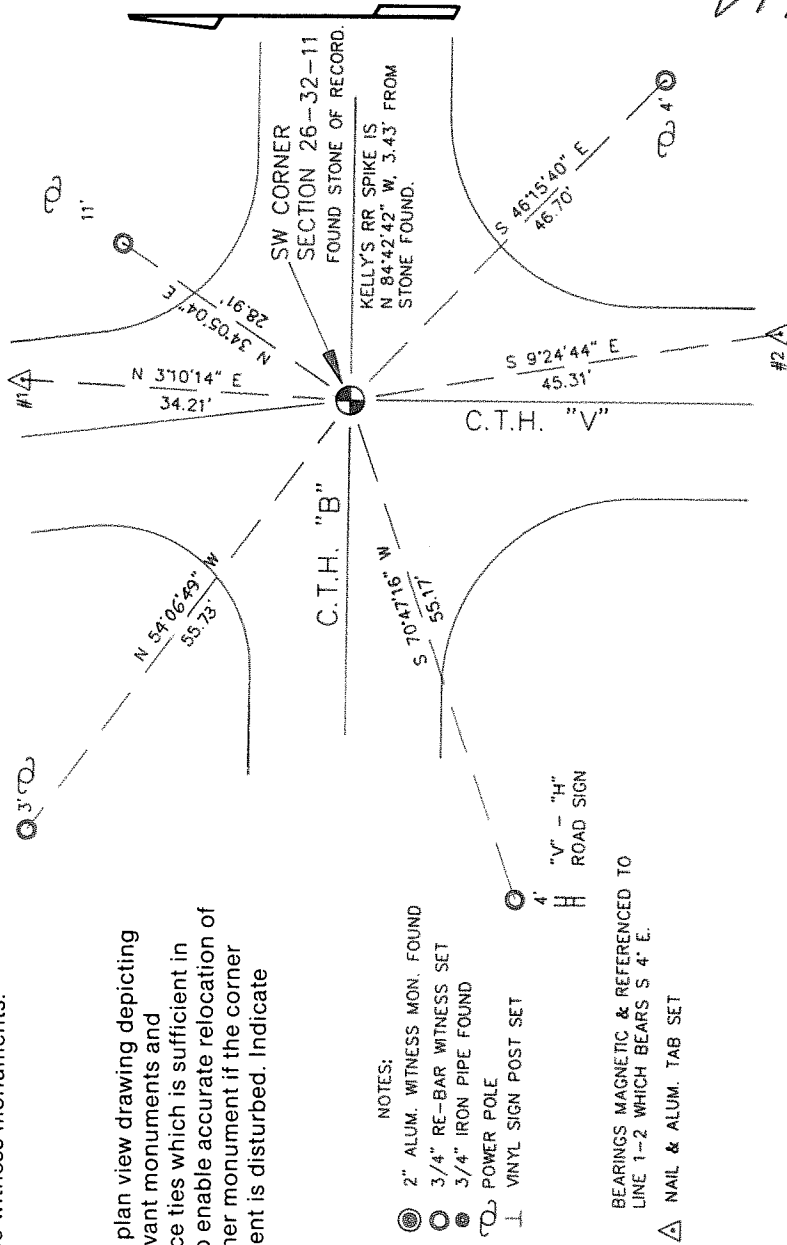
- (b) Describe any record evidence, monument evidence, occupational evidence, testimonial evidence or any other material evidence you considered, and whether the monument was found or placed.
 The original corner was established in 1860 by Hiram C. Fellows. Original B.T.'s: lind, 10", S17°W, 7 lks., and an ironwood, 7", N70°E, 12 lks. In 1902 Weibly set a boulder, 10" x 10" x 24" with cross on top, in place of stake.
 In 1986, former surveyor Kelly - "corner reestablished from information received from David Gallenberg, resident witness, in June of 1986. Set new witness monuments". 07/29/96 D. Tlusty, M. Keilcheski dug with backhoe and found stone as described by Weibly, top of stone 2.3' below road surface. Accepted as best evidence of original corner location. Set 3/4" x 30" re-bar on north side of stone and 3/4" x 18" x iron pipe on south side of stone. Stone found is about 3.5' east of Kellys RR spike. Both of Kellys aluminum witness monuments are gone.

- NOTES:
 ● 2" ALUM. WITNESS MON. FOUND
 ○ 3/4" RE-BAR WITNESS SET
 ⊙ 3/4" IRON PIPE FOUND
 ⊕ POWER POLE
 ⊥ VINYL SIGN POST SET
 4" H "V" - "H" ROAD SIGN
 ⊠ NAIL & ALUM. TAB SET
- BEARINGS MAGNETIC & REFERENCED TO LINE 1-2 WHICH BEARS S 4° E.
