# U. S. PUBLIC LAND SURVEY MONUMENT RECORD

The South 1/4 corner of Section 17, Township 33 North, Range 11 East, Langlade County, Wisconsin.

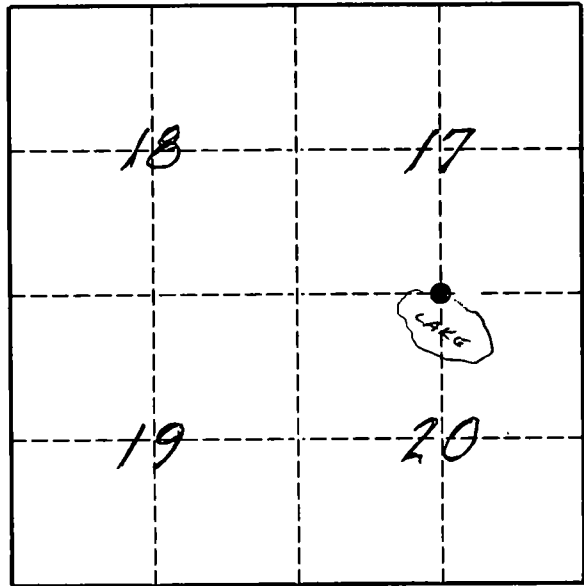
T. 33 N., R. 11 E.

● = Corner monument restored.

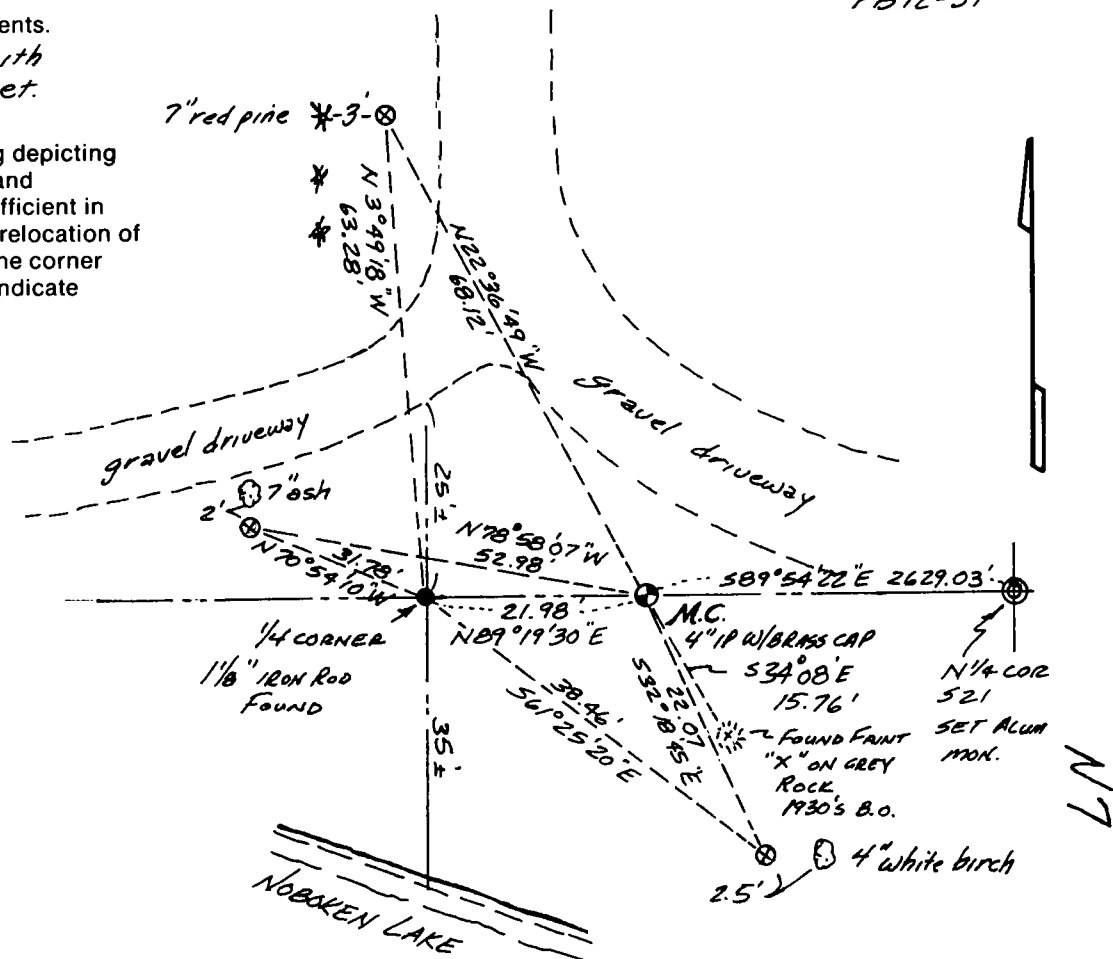
This corner was not established in the original government survey. The 1930's re-survey set a 1 1/8" x 26" iron rod for this corner, 22' west of the MC. 07/24/96 Dave Tlusty found 1 1/8" iron rod for corner, 21.98' west of MC. Found iron pipe (1") SW, 2.6' from the 1/4 corner, as described in the 1930's notes. The corner is 1' SE of a power pole guy wire anchor. Set vinyl sign post 1' north of corner.

⊗ = 3/4" x 30" re-bar with red plastic cap set.

No discrepancy. Note: The original government survey notes indicate that this corner was in water and not set. The iron rod found is approximately 35 feet north of the waters edge of Noboken Lake, and it is on the edge of a bank that is approximately 10' to 15' above the lake.
