U.S. PUBLIC LAND SURVEY MONUMENT RECORD

INDEX NO. P-1 P25
33-14

QUARTER Corner to Section 9 - 24 T 33 N, R 15 E (Section/Quarter)

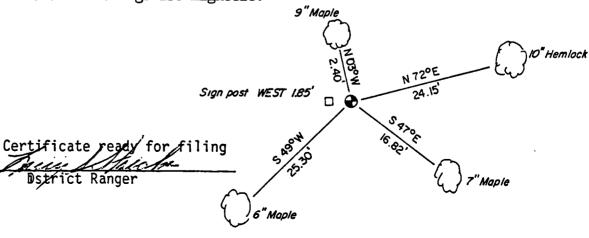
NORTH N.T.S.

I searched the single proportionate position for this corner location and North of this position approximately one chain I found a Sugar blazed on two sides. I found a large Hemlock stump rotted at ground level from which I measured N87E for 18 links and located a post hole with vertical cedar remnants. From this post hole I measured N50E for 28 links and located a depression from which Birch progeny was growing. I monumented the post hole from the bearing tree evidence.

Set a 2"x 36" aluminum post with the cap stamped for the corner in a mound of stone. Distances are to aluminum nails in the trees shown. Bearings are magnetic.
