U. S. PUBLIC LAND SURVEY MONUMENT RECORD

Quarter Corner to Sections 31 and 36, T.33N., R.14-15E.

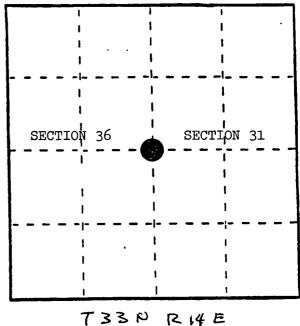
Describe witness monuments. (c)
- Show a plan view drawing depicting the relevant monuments and reference ties which is sufficient in detail to enable accurate relocation of the corner monument if the corner monument is disturbed. (d) Indicate north.
- 1. Oconto County Monument
- 2. Sugar, 5", S.71°E., 30.10 feet 3. Sugar, 8", S.09°W., 33.24 feet 4. Sugar, 5", N.29°W., 7.19 feet

- 5. Steel Sign Post, Northeast, 1.05 feet
