CEDTICIED	LAND	CODNED	DESTORATION
しになりけにし	LAND	CORNER	RESTORATION

Otate of Wiscom	\ cc			
County of LAMGLADE				
I WM. F. KELLY	do hereby			
certify that on the	TH day			
of July	, 19. 74 , I found			
evidence of the Sec.	100			
corner of Secs. 26-2	1- 34-35			
Township 34	, North, Range			
	n Principal Meridian,			
as described hereon; and th	at from this evidence			
I established a new monument and accessories				
as described hereon to perpetuate the original

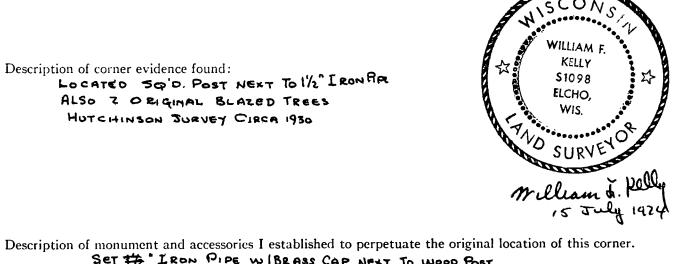
O = Corner monument restored.

SET THE " IRON PIPE WIBEASS CAP NEXT TO WOOD POST. REMAINS OLD PINE STUMP TT SCRIBED 27 8T NZTW 19.5 NBTS BLAZED CHESTHIGH O+2"IPW/BRASS <AP DEAD TREE W SCRIBE 27 BT 5431/2W 9.8 CEDAR 14 "SZG W 18.3 MKD NBT ELCHO, Wis., this 15TH day of JULY , 1974 Dated at. Si
