CERTIFIED LAND CORNER RESTORATION

34-12

Index No. Z-9

PLSS field condition report

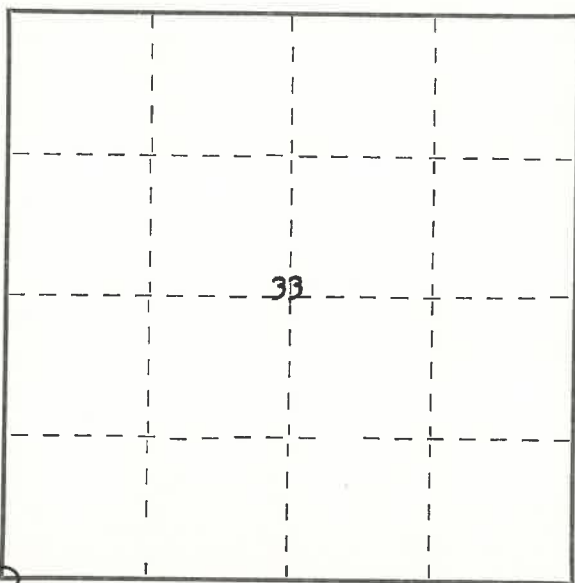
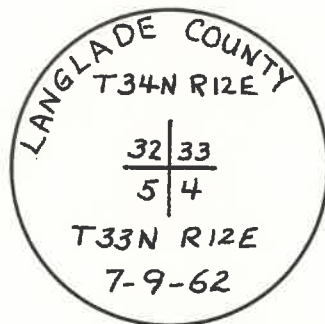
Set brass cap welded into a 4 foot section of 1 $\frac{1}{4}$ " pipe. Pipe extending 2 $\frac{1}{2}$  feet above ground.

New BT cedar 5.6" N 38°E 9.5' (compass set at 0°) Markings S' 33 BT

New BT cedar stump 16" S 44° E 34' (compass set at 0°) Markings S 4 B.T.
