I, David E. Tlusty, Professional Land Surveyor do hereby certify that by the direction of the Langlede County Forestry Department, I made a survey of the South line of Government Lot 11, Section 25, Township 33 North, Range 10 East, Langlede County, Wisconsin, as shown hereon. I further certify that this map is a true and correct representation of said survey and that this survey has been made in conformance with A-E 7 of the Wisconsin Administrative Code and that it is correct to the best of my knowledge and belief.

<b>David E. Tlusty, PLS</b> Deerbrook, Wisconsin 54424			
Survey for Langlede County Forestry Dept. The South line of Gov't. Lot 11/ North line of Gov't. Lot 16, in Section 25, T. 33 N., R. 10 E.			
SCALE: 1" = 25'	DATE: 10/26/2021	DRAWN BY: dt	MAP #:

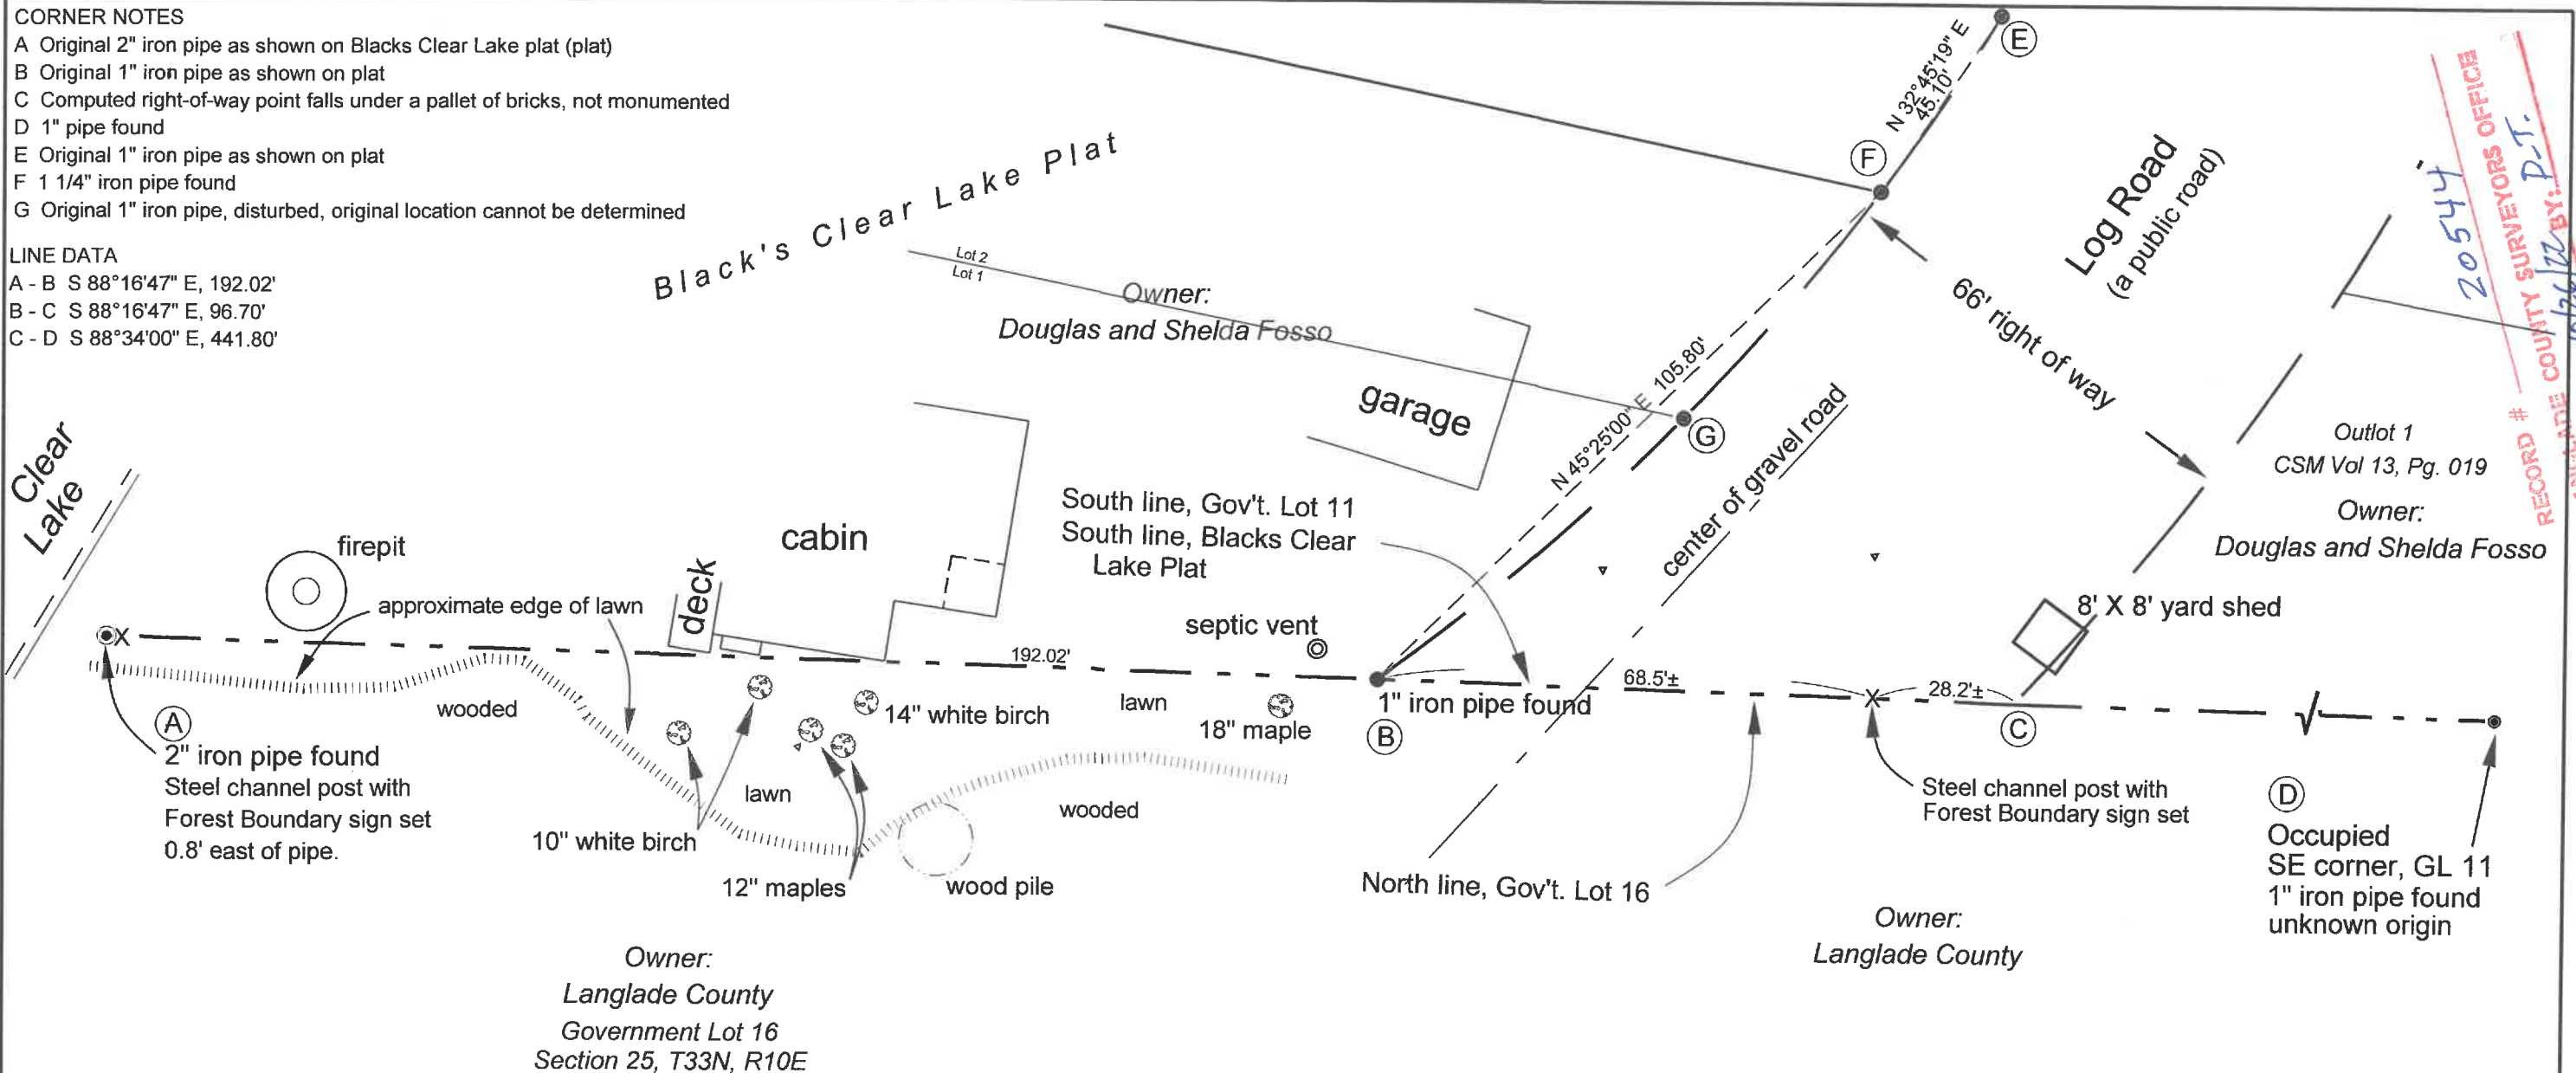
- A Original 2" iron pipe as shown on Blacks Clear Lake plat (plat)
- B Original 1" iron pipe as shown on plat
- C Computed right-of-way point falls under a pallet of bricks, not monumented
- D 1" pipe found
- E Original 1" iron pipe as shown on plat
- F 1 1/4" iron pipe found
- G Original 1" iron pipe, disturbed, original location cannot be determined

- A - B S 88°16'47" E, 192.02'
- B - C S 88°16'47" E, 96.70'
- C - D S 88°34'00" E, 441.80'

Bearings shown are referenced to the Langlede County coordinate system grid.
