SURVEY OF CATHEDRAL POINT LANE FOR THE TOWN OF ELCHO, LANGLADE COUNTY, WISCONSIN.

SURVEY OF  
CATHEDRAL POINT LANE  
FOR THE TOWN OF ELCHO,  
LANGLADE COUNTY, WISCONSIN.

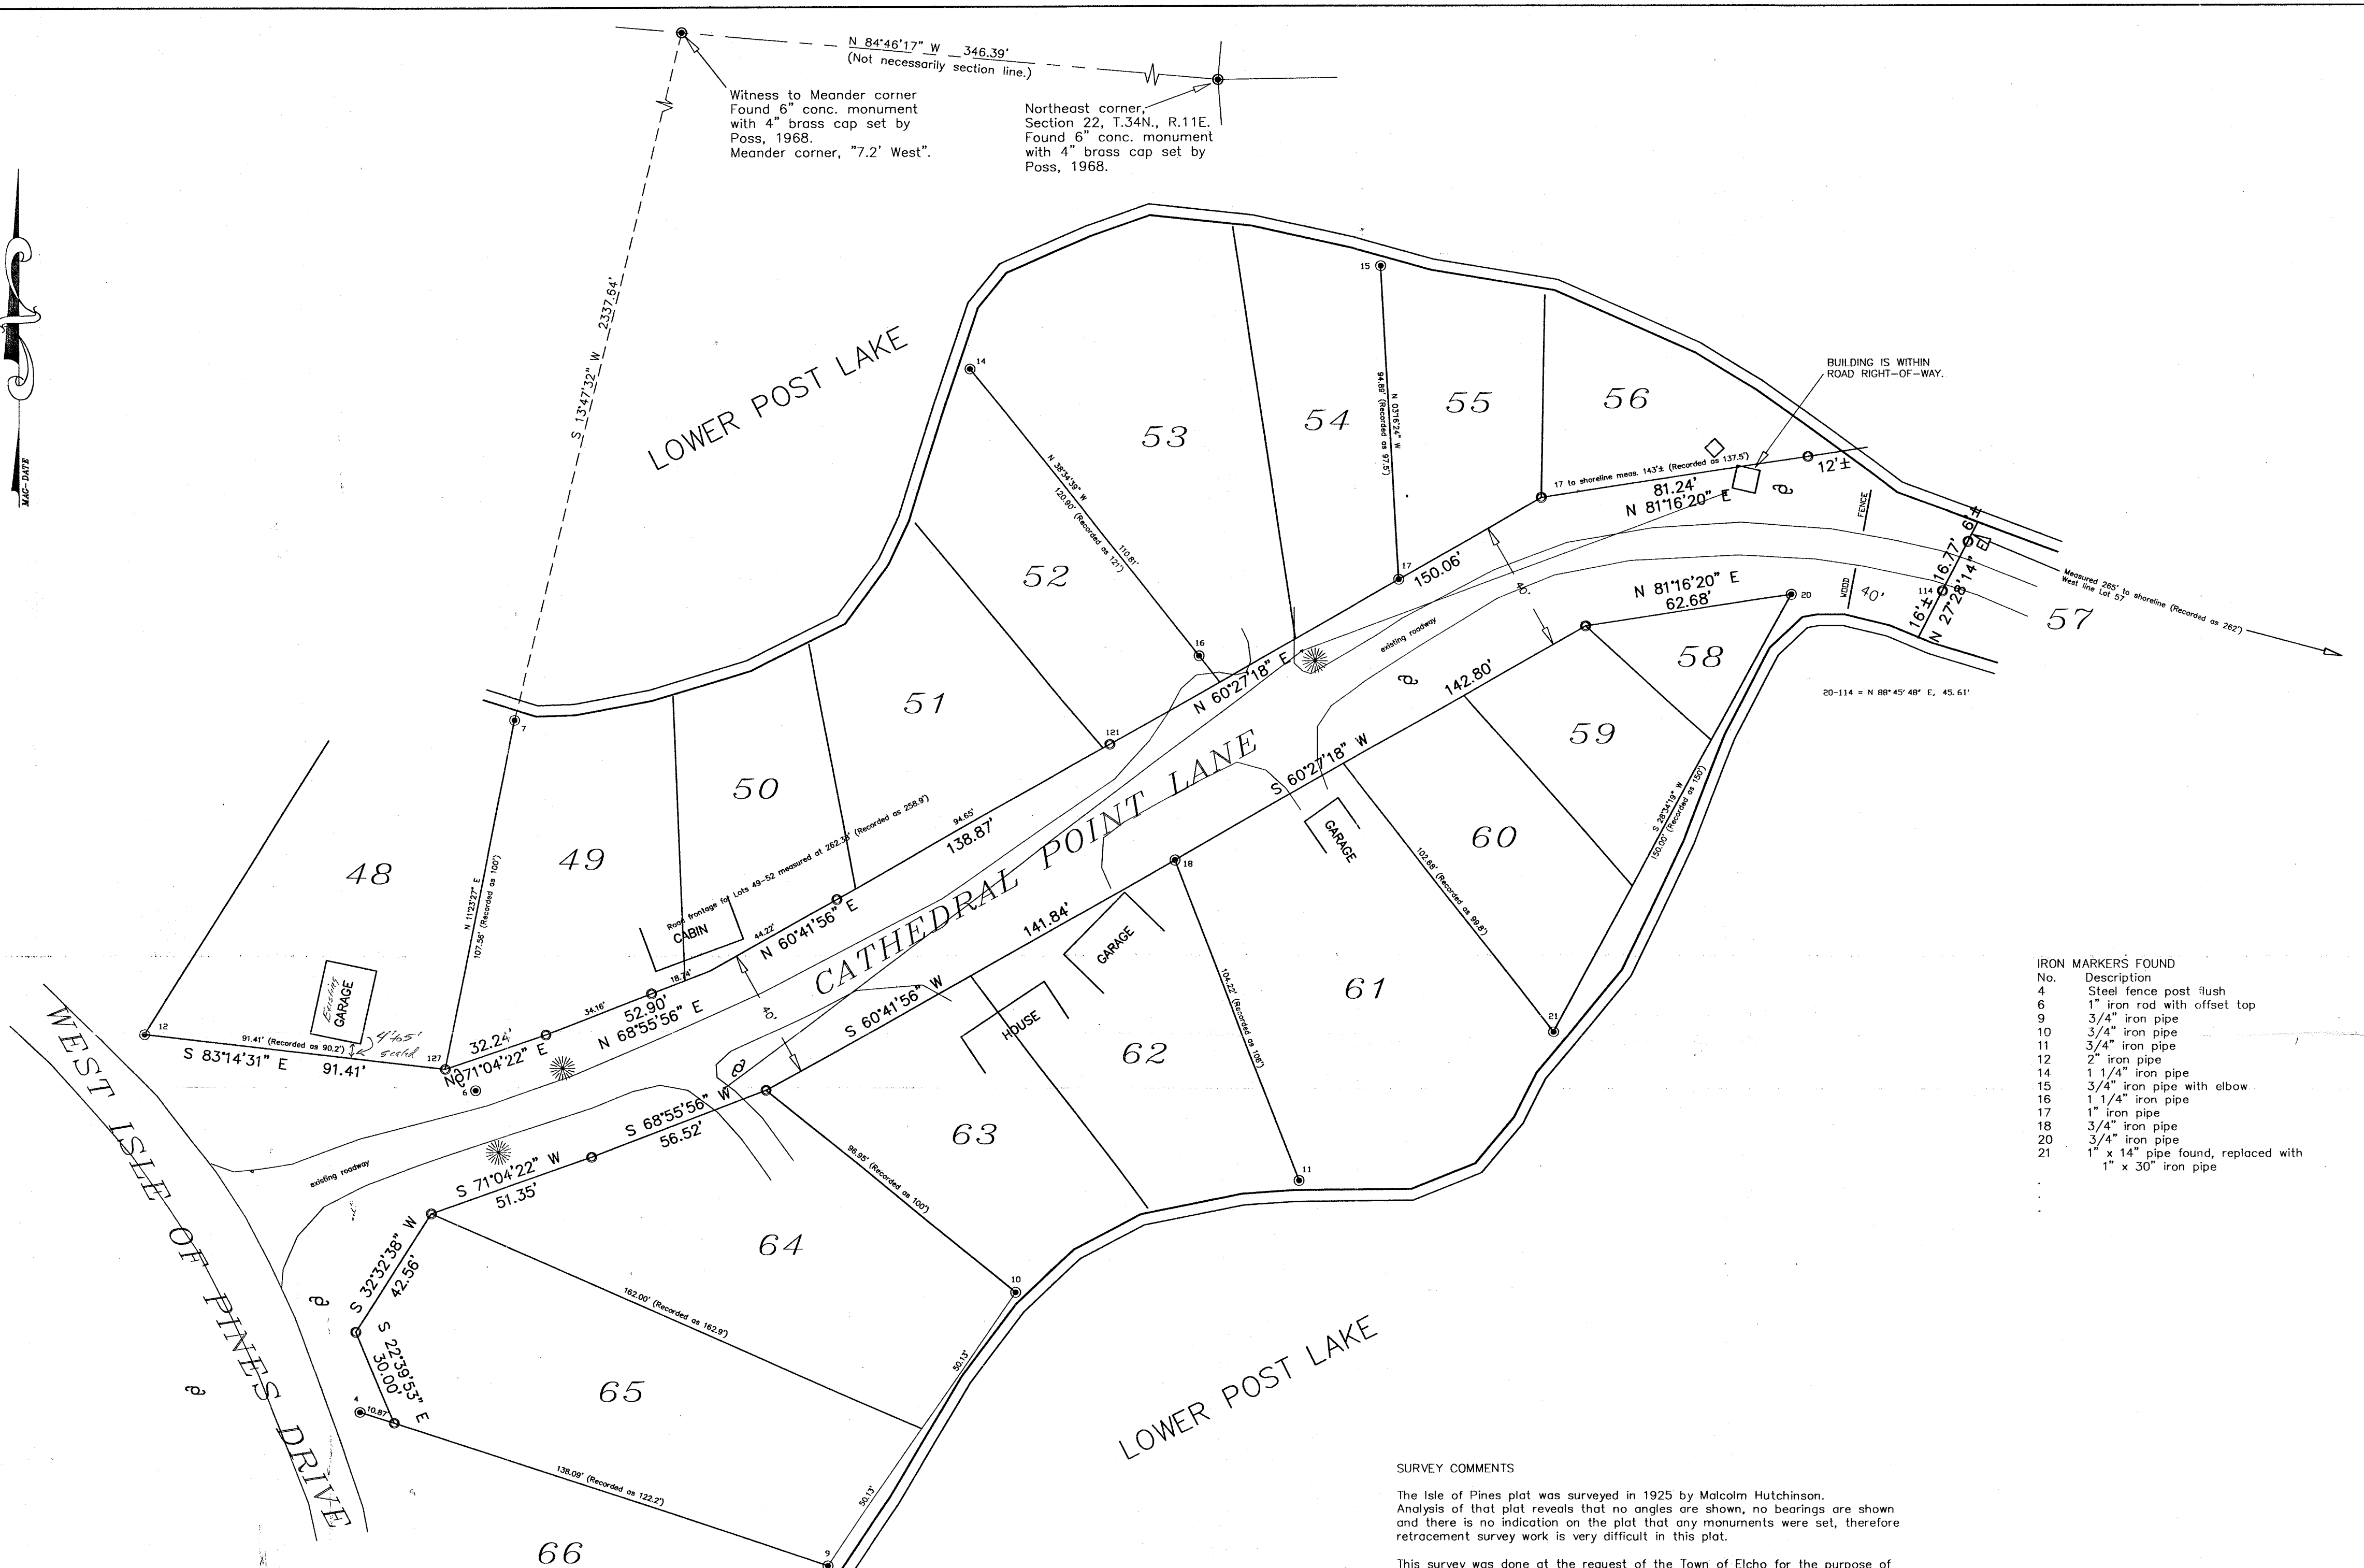
The Isle of Pines plot was surveyed in 1925 by Malcolm Hutchinson. Analysis of that plot reveals that no angles are shown, no bearings are shown and there is no indication on the plot that any monuments were set, therefore retracement survey work is very difficult in this plot.

This survey was done at the request of the Town of Elcho for the purpose of locating the right-of-way of Cathedral Point Lane, a road that was laid out in the original plot. The location of the easterly portion of this right-of-way was determined from existing iron markers (17, 18 & 20), which seem to make the road-to-shoreline distances work in the area of Lots 54 thru 60. The location of the right-of-way from the area of Lots 52 & 62 west to West Isle of Pines Drive was determined by using the approximate center of the existing traveled roadway. This procedure seemed to result in a right-of-way that closely resembles the right-of-way shown on the original map of Isle of Pines.

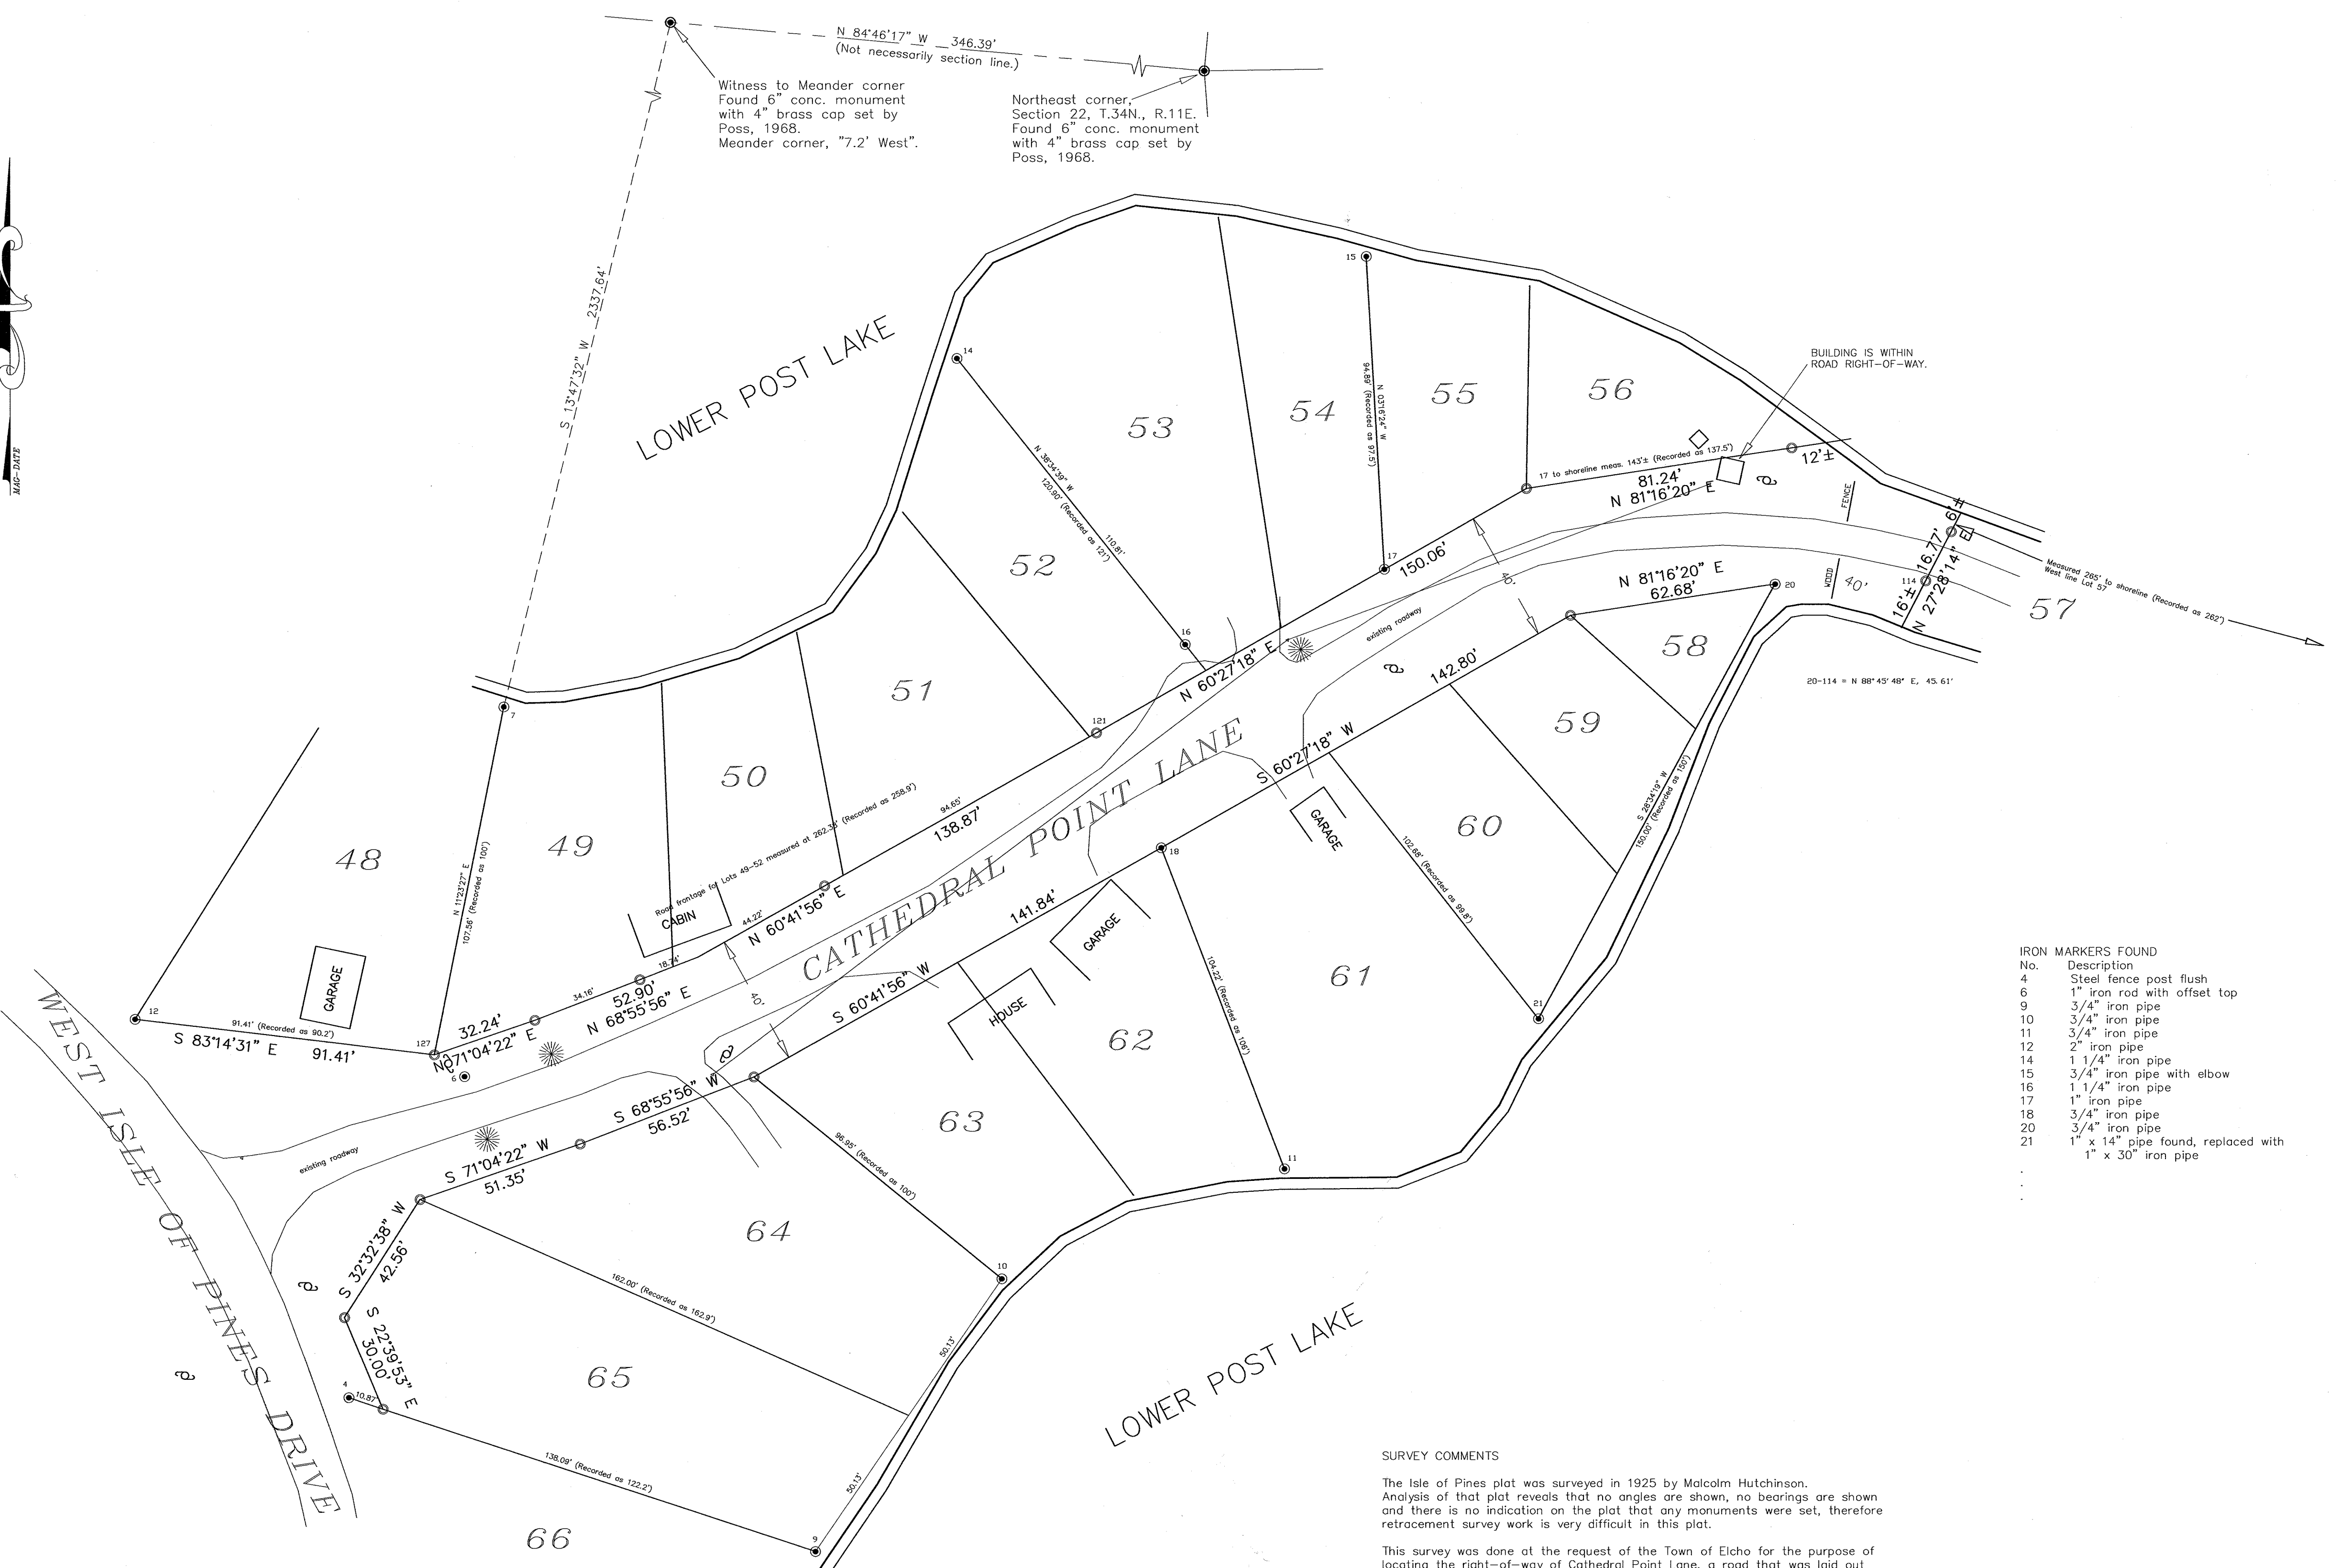
Witness to Meander corner  
Found 6" conc. monument  
with 4" brass cap set by  
Poss, 1968.  
Meander corner, "7.2' West".

Northeast corner,  
Section 22, T.34N., R.11E.  
Found 6" conc. monument  
with 4" brass cap set by  
Poss, 1968.

The Isle of Pines plat was surveyed in 1925 by Malcolm Hutchinson. Analysis of that plat reveals that no angles are shown, no bearings are shown and there is no indication on the plat that any monuments were set, therefore retracement survey work is very difficult in this plat.

This survey was done at the request of the Town of Elcho for the purpose of locating the right-of-way of Cathedral Point Lane, a road that was laid out in the original plat. The location of the easterly portion of this right-of-way was determined from existing iron markers (17, 18 & 20), which seem to make the road-to-shoreline distances work in the area of Lots 54 thru 60. The location of the right-of-way from the area of Lots 52 & 62 west to West Isle of Pines Drive was determined by using the approximate center of the existing traveled roadway. This procedure seemed to result in a right-of-way that closely resembles the right-of-way shown on the original map of Isle of Pines.
